Updating your computer and Multi to VEConfigure3

v9 – March 15th 2013

Updating the MK2.2a for the Global Remote

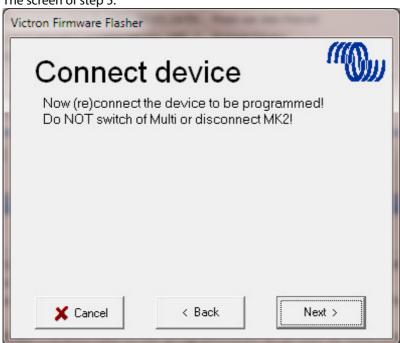
The screen of step 5:

At step 5 of above procedure, first connect the MK2.2a to the VE.Bus cable. Then create a short-circuit between the two pins indicated by an arrow. Touching both pins with a simple screwdriver will do the job, the short needs to be there only very briefly. Remove the short circuit before pressing "Next".

- 1. Start VEFlash and choose update firmware.
- 2. Open the firmware file 1130132b.vff.
- 3. Select the comport to which the normal MK2-USB is connected.
- 4. At the "Read carefully!" screen: Disconnect the MK2.2a from the VE.Bus cable
- 5. At the "Connect device" screen: Connect the MK2.2a again to the VE.Bus cable
- 6. Continue with the on screen instructions. Attention: The Multi/Inverter/Quattro will be turned off by the software. Do not switch it off yourself!
- 7. Press OK when VEFlash is finished
- 8. Disconnect the normal MK2 from the Multi/Inverter/Quattro
- 9. Now switch off the Multi/Inverter/Quattro and switch it on again.
